**SITE ASSESSMENT REPORT
FOR
ROSE EXTERMINATOR SITE
NORWOOD, HAMILTON COUNTY, OHIO**

NPL STATUS: NON-NPL

Date Prepared	February 27, 2009
TDD Number	S05-0001-0811-008
Document Control Number	565-2A-AADM
Contract Number	EP-S5-06-04
START Project Manager	Frank Beodray
Telephone Number	(440) 202-2806
U.S. EPA On-Scene Coordinator	Steven L. Renninger

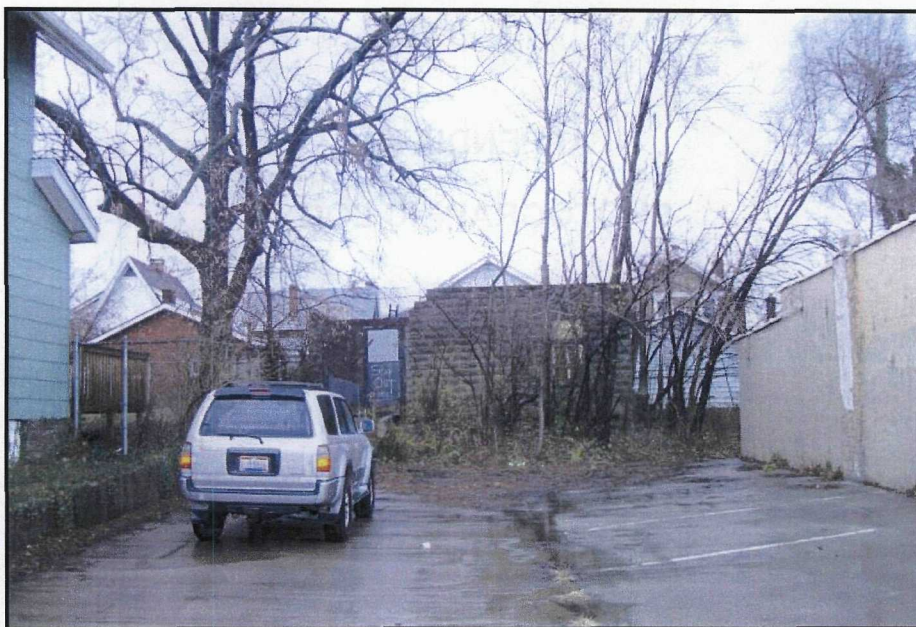
Photograph No.: 1

On December 18, 2008, WESTON START member John Sherrard and U.S. EPA On-Scene Coordinator (OSC) Steve Renninger conducted a site reconnaissance. WESTON START observed a vacant concrete-block storage building with no roof at the Site. The door to the building was secured by a nailed wood board. Evidence of trespassing was indicated by toys and trash piled inside the building. WESTON START also observed residential homes within 50 feet of the storage shed on the Site's western and southern perimeters. Before leaving the Site, OSC Renninger and WESTON START formulated a sampling plan for the site assessment to be conducted on December 30, 2008.

During the December 30, 2008, U.S. EPA site investigation, WESTON START noted that the Site building structure was damaged. Debris including concrete blocks, wood beams, toys, vegetation, and trash is scattered inside the building, which contains evidence of trespassing. White staining (arsenic contamination) is visible on the inside walls of the building.

Subject: Vacant storage building viewed from Carthage Avenue

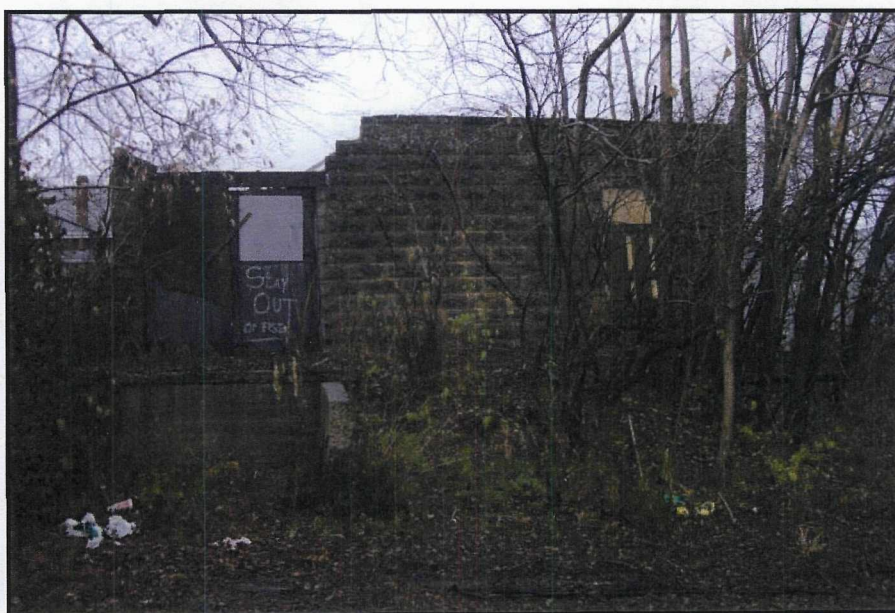
Photograph No.: 2

Subject: Vacant storage building

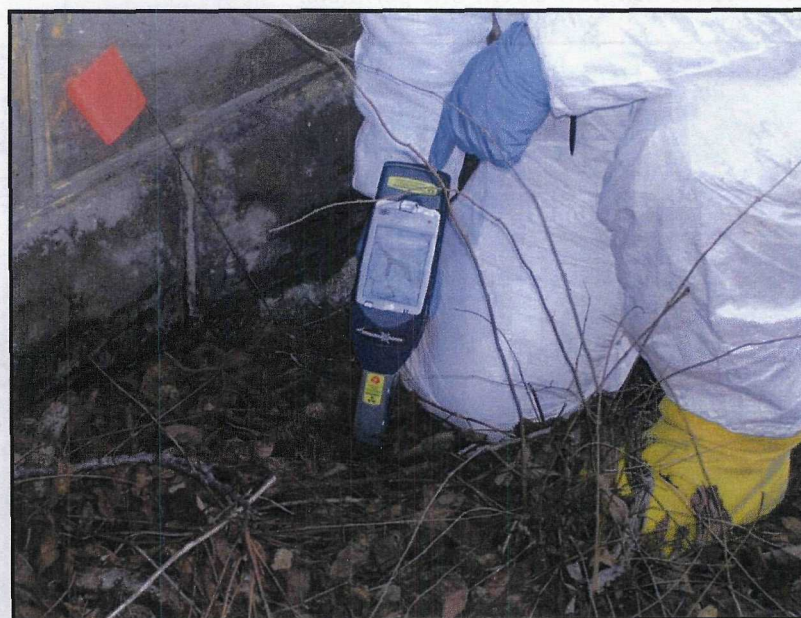
Photograph No.: 6

Subject: Close-up view of XRF unit
